## Tree/Sidewalk Conflicts: One Way to Save Trees

By: Megan Dettenmaier, USU Forestry Extension Educator,  
and Michael R. Kuhns, USU Forestry Extension Specialist

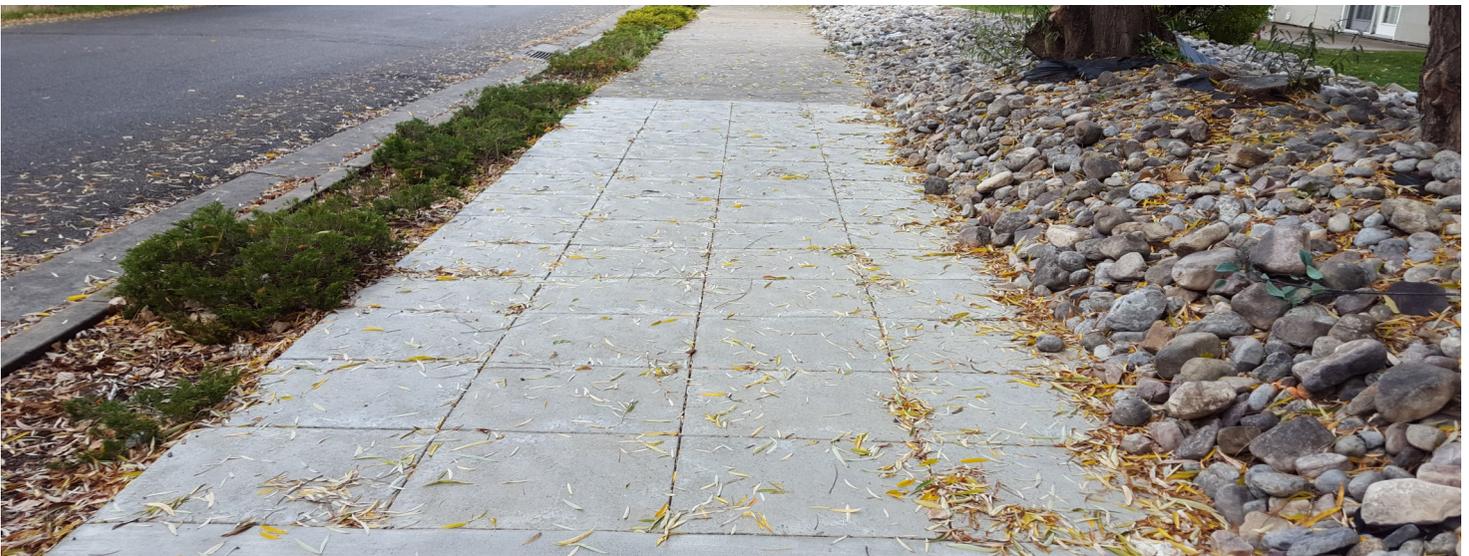
One sidewalk installation site in Logan located at 500 W Fairway Lane. Willow trees to the east were able to stay in place because the sidewalk tiles were used to replace the sidewalk that had been damaged by the tree roots.

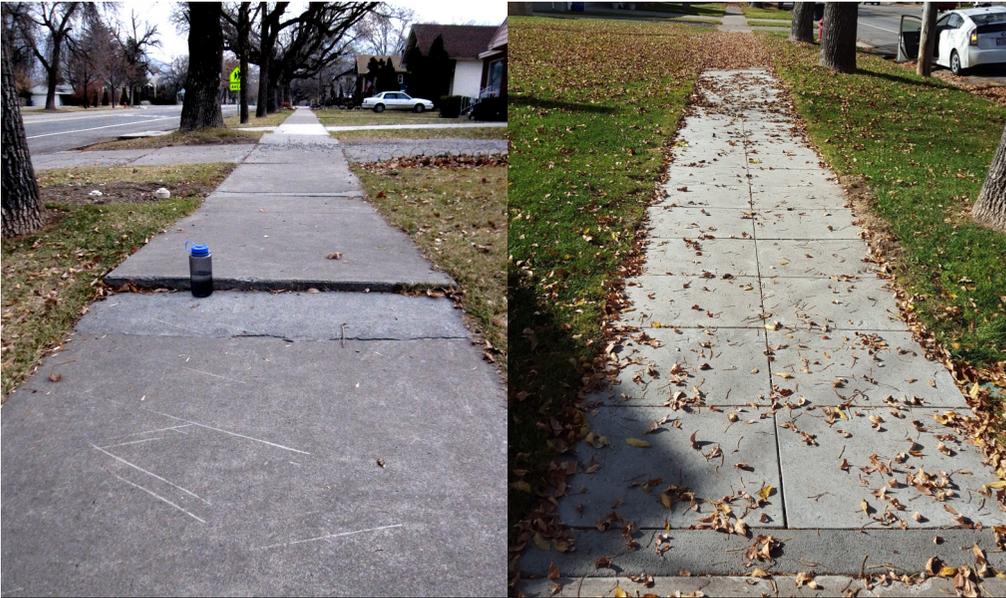
Before and after sidewalk located on the south side of 200 North between 400 and 500 West (444 W 200 N) in Logan. This sidewalk was excavated and sidewalk tiles were installed in fall 2015.

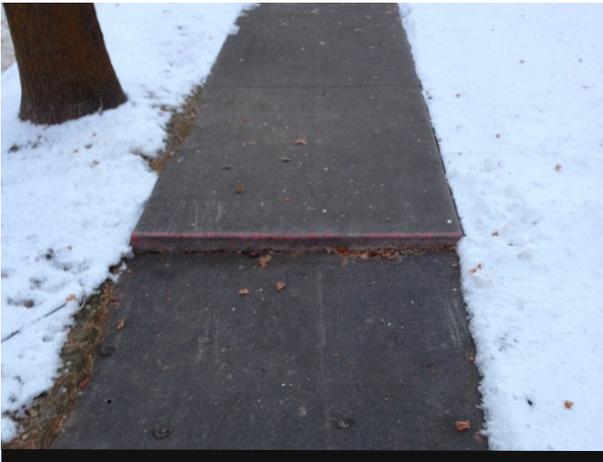
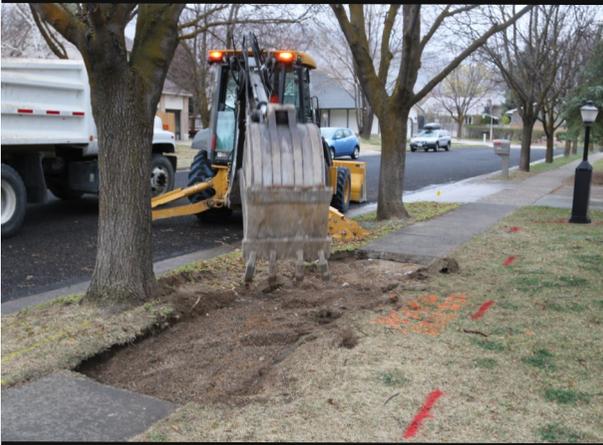
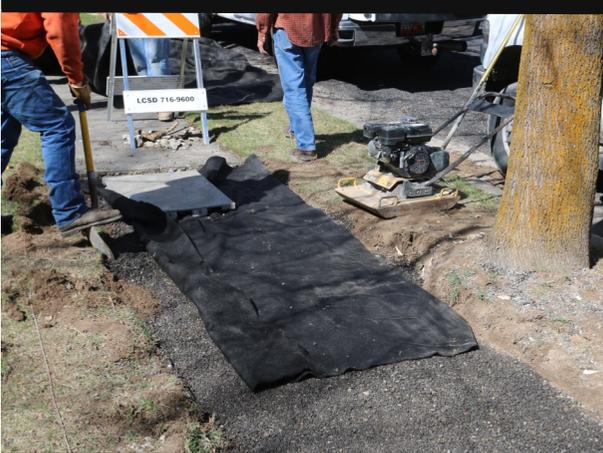
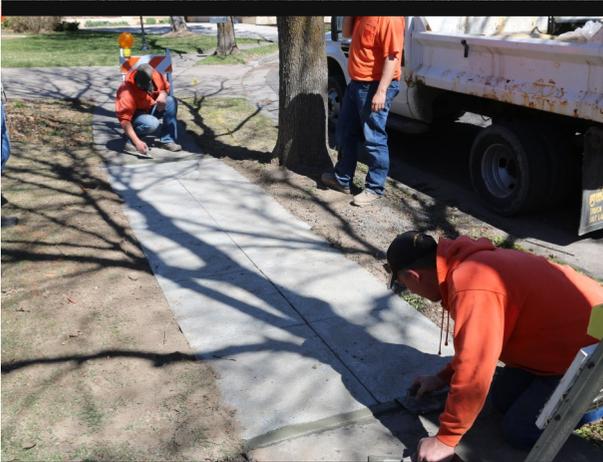
Site selection, excavation, preparation and installation. This sidewalk is located about a block west of 1600 east at 1385 North in Logan.

Logan City crews removed damaged sidewalk slabs by reaching in with a backhoe from the street, taking care not to disrupt tree roots and tops, irrigation equipment, and nearby vegetation. Heavy equipment was kept off of the surrounding soil to avoid compaction. Concrete slabs were removed near the tree in either direction out to a point where the sidewalk was level and otherwise in good shape, usually a total of 10 to 15 feet. When possible the concrete was separated at an expansion joint, but in some cases a saw was needed to separate the damaged concrete from the remaining sidewalk. In most cases additional aggregate or base material (i.e., gravel) had to be added to fill in low areas and to bring the fill level up to the appropriate height. Terrewalks<sup>®</sup> panels are thinner than typical concrete sidewalk slabs and will shift if the base is not compacted and level. From our observations, it is a good idea to place base material so that the panels

A tree expert visited each site and assessed the condition of the tree roots that caused the sidewalk damage. Roots were cut if they extended up into where the panel was going to be placed, but this usually was not necessary. Roots that pressed tightly against the bottom of the concrete usually were not considered a problem and were left alone. This certainly is a compromise since it means that the sidewalk panels will deflect earlier than they would have if the entire tree and all its roots were removed and a full bed of base material was present. However, this entire process is a compromise that is done to save trees or at least to delay their removal. In only one situation did a very large root need to be cut. This root was cut cleanly on the end extending from the tree to aid in healing. The backhoe was never used to remove roots since pulling on woody roots until they break shatters the remaining root well away from where the root breaks.

Once the damaged sidewalk was removed and any problem roots were assessed and/or cut, a layer of aggregate / base fill was put down and carefully compacted. Then a permeable textile fabric was laid which helped to stabilize the base. Once the site was prepared, the sidewalk panels were locked into each other with integral lugs and spiked along the edges. Concrete was poured at each end of the installation to stabilize the panels and tie them into the existing sidewalk. Spacing shims ( $\frac{1}{4}$  inch thick) were placed temporarily between panels as they were laid to ensure that there was adequate room for expansion. A detailed explanation of each step is outlined in the [installation manual](#).

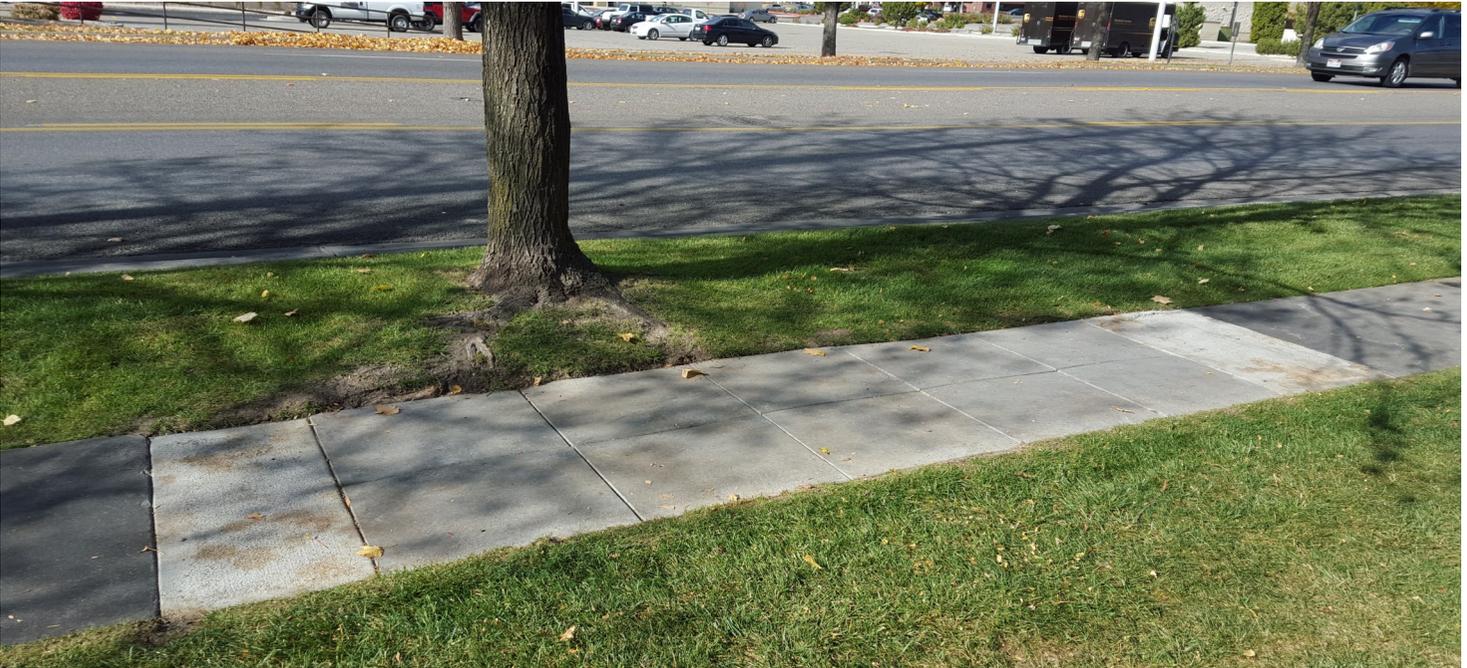
Another sidewalk installation site in Logan located at 1300 North 200 East. The close proximity of the Cache Valley Mall and Logan Pointe Apartments made this sidewalk a high priority for Logan City officials after the adjacent tree had buckled the old sidewalk in multiple places.
