# Alternative Indicators of BMP effectiveness: **Analysis of Changes in the Riparian Zone**

Doug Jackson-Smith  
Christopher Neale  
USU

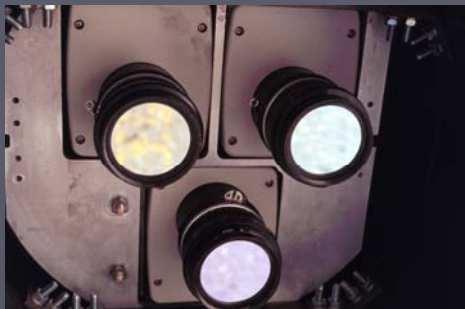
**Kodak 4.2i digital cameras with interference filters forming spectral bands.**

**The cameras are mounted on carbon composite and high-grade aluminum mount**

- ▶ Multispectral Imagery were acquired using the USU airborne system
- ▶ In 1992, the first version of the system was used which was based around video cameras
- ▶ In 2007, the imagery were acquired using the latest version of the system, based on digital cameras
- ▶ Both systems were flown on USU's remote sensing aircraft

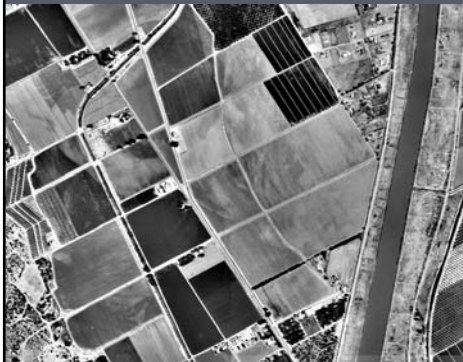
Digital Orthophoto Map Base

Individual 3-band images are rectified to a digital ortho map base using common, well defined control points visible in both sets of images and a polynomial transformation

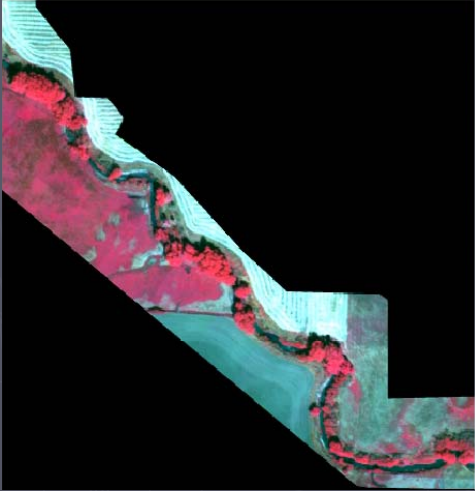
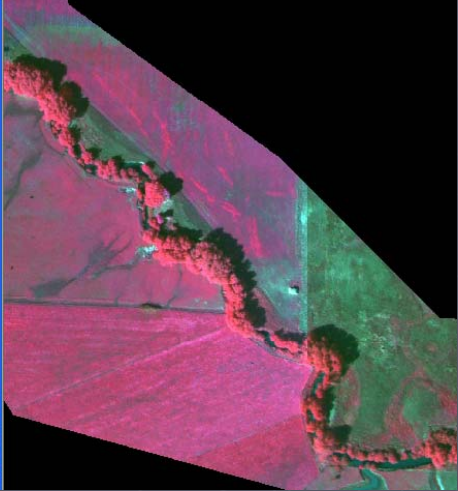
Detail 1

### Site: Downstream from Hyrum Dam

1992 Multispectral Mosaic	2007 Multispectral Mosaic
---------------------------	---------------------------

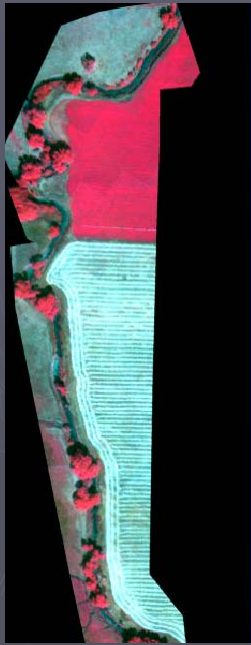
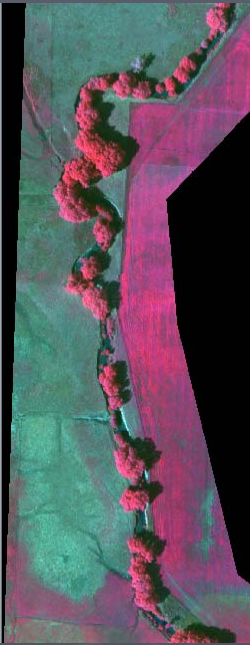
Detail 2

1992 Multispectral Mosaic	2007 Multispectral Mosaic	<h3 style="text-align: center;">Site: Downstream from Hyrum Dam</h3>
---------------------------	---------------------------	--

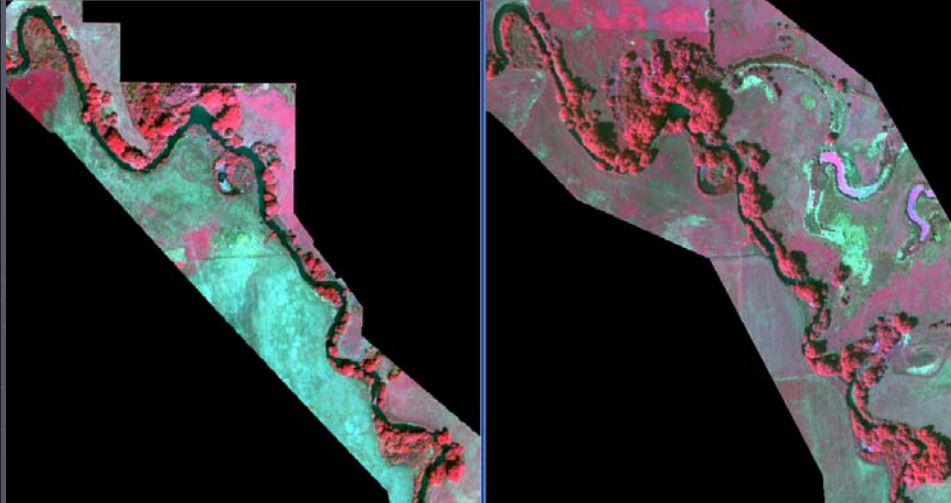
Detail 3

### Site: Downstream from Hyrum Dam

1992 Multispectral Mosaic

2007 Multispectral Mosaic

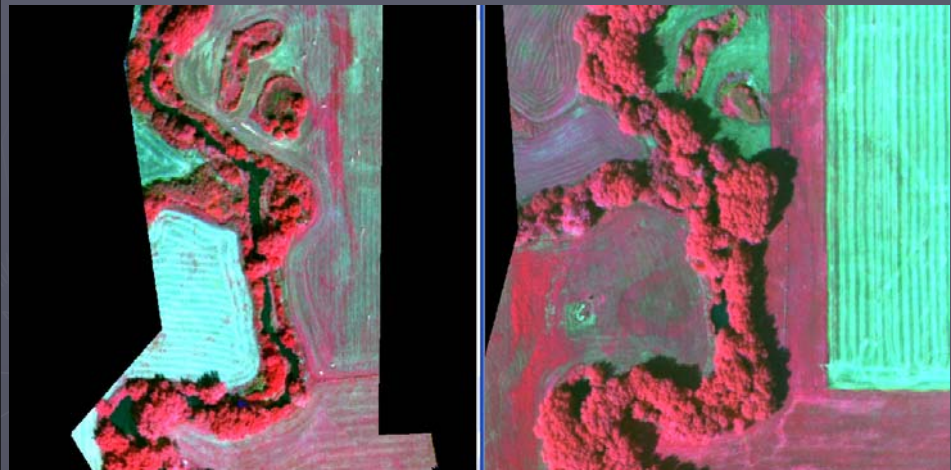
Detail 4

### Site: Downstream from Hyrum Dam

1992 Multispectral Mosaic

2007 Multispectral Mosaic
