Tree/Sidewalk Conflicts: One Way to Save Trees

By: Megan Dettenmaier, USU Forestry Extension Educator,
and Michael R. Kuhns, USU Forestry Extension Specialist

This factsheet describes a project undertaken by USU Forestry Extension and the City of Logan, Utah, to replace damaged sidewalks with flexible sidewalk panels made from 100% recycled plastic. These tiles allowed trees and most tree roots to remain intact. We explain the project methods, as well as the pros and cons of undertaking such a project. These materials and methods have the potential to change sidewalk and urban tree management practices.

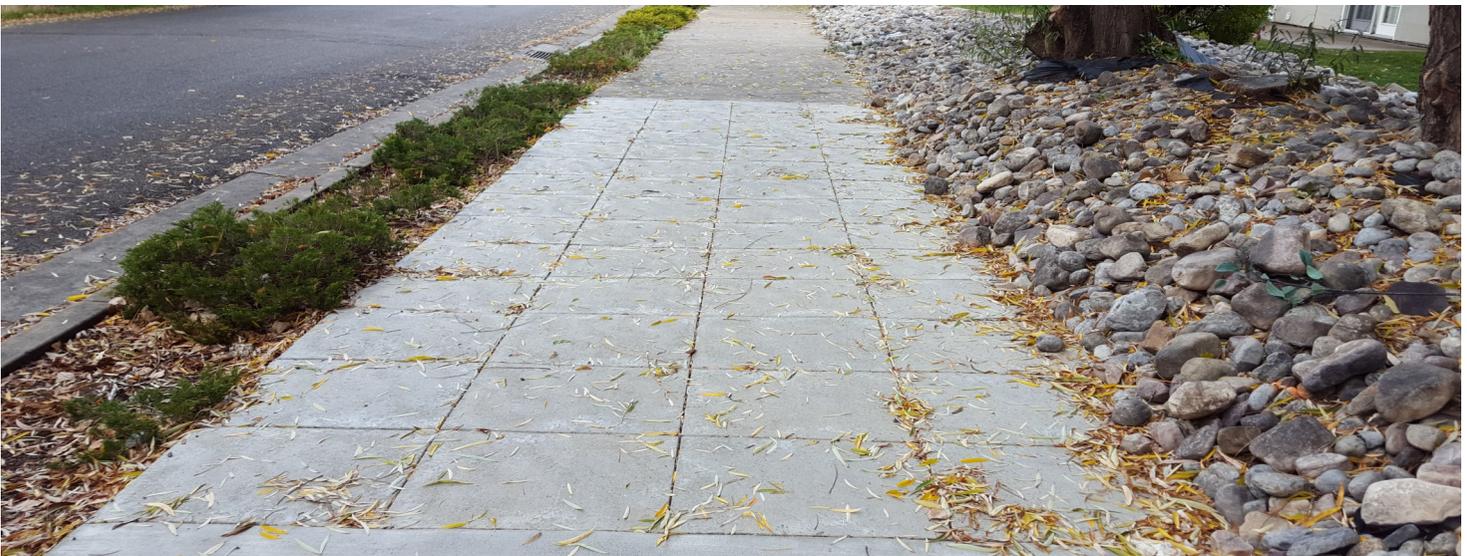
One sidewalk installation site in Logan located at 500 W Fairway Lane. Willow trees to the east were able to stay in place because the sidewalk tiles were used to replace the sidewalk that had been damaged by the tree roots.

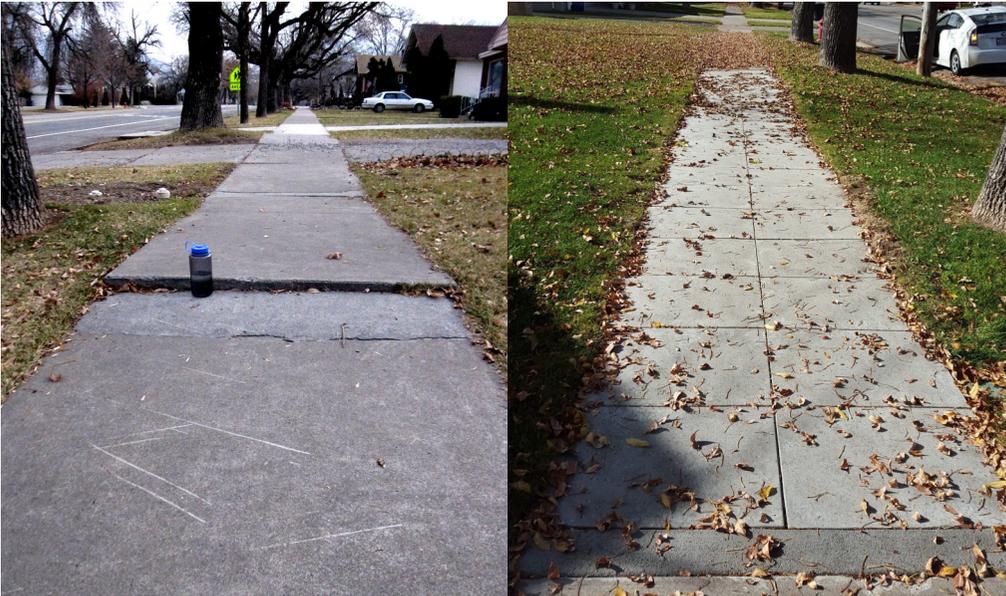
Before and after sidewalk located on the south side of 200 North between 400 and 500 West (444 W 200 N) in Logan. This sidewalk was excavated and sidewalk tiles were installed in fall 2015.

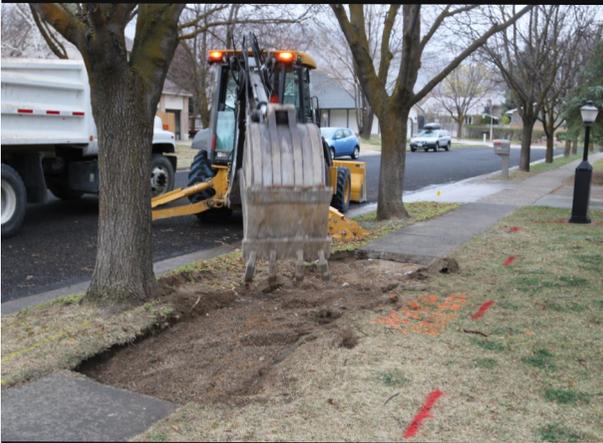
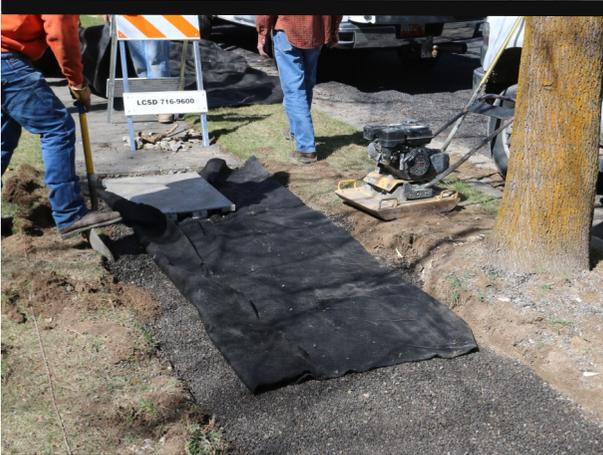
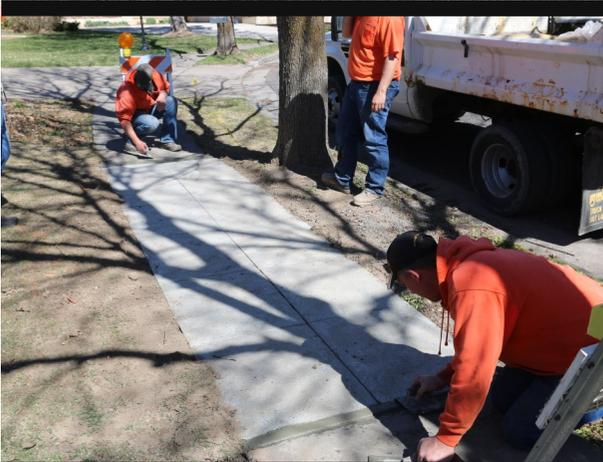
Site selection, excavation, preparation and installation. This sidewalk is located about a block west of 1600 east at 1385 North in Logan.

Logan City crews removed damaged sidewalk slabs by reaching in with a backhoe from the street, taking care not to disrupt tree roots and tops, irrigation equipment, and nearby vegetation. Heavy equipment was kept off of the surrounding soil to avoid compaction. Concrete slabs were removed near the tree in either direction out to a point where the sidewalk was level and otherwise in good shape, usually a total of 10 to 15 feet. When possible the concrete was separated at an expansion joint, but in some cases a saw was needed to separate the damaged concrete from the remaining sidewalk. In most cases additional aggregate or base material (i.e., gravel) had to be added to fill in low areas and to bring the fill level up to the appropriate height. Terrewalks[®] panels are thinner than typical concrete side-

walk slabs and will shift if the base is not compacted and level. From our observations, it is a good idea to place base material so that the panels end up a little high so they will be flush with the remaining sidewalk after they settle.

Once the damaged sidewalk was removed and any problem roots were assessed and/or cut, a layer of aggregate / base fill was put down and carefully compacted. Then a permeable textile fabric was laid which helped to stabilize the base. Once the site was prepared, the sidewalk panels were locked into each other with integral lugs and spiked along the edges. Concrete was poured at each end of the installation to stabilize the panels and tie them into the existing sidewalk. Spacing shims ($\frac{1}{4}$ inch thick) were placed temporarily between panels as they were laid to ensure that there was adequate room for expansion. A detailed explanation of each step is outlined in the [installation manual](#).

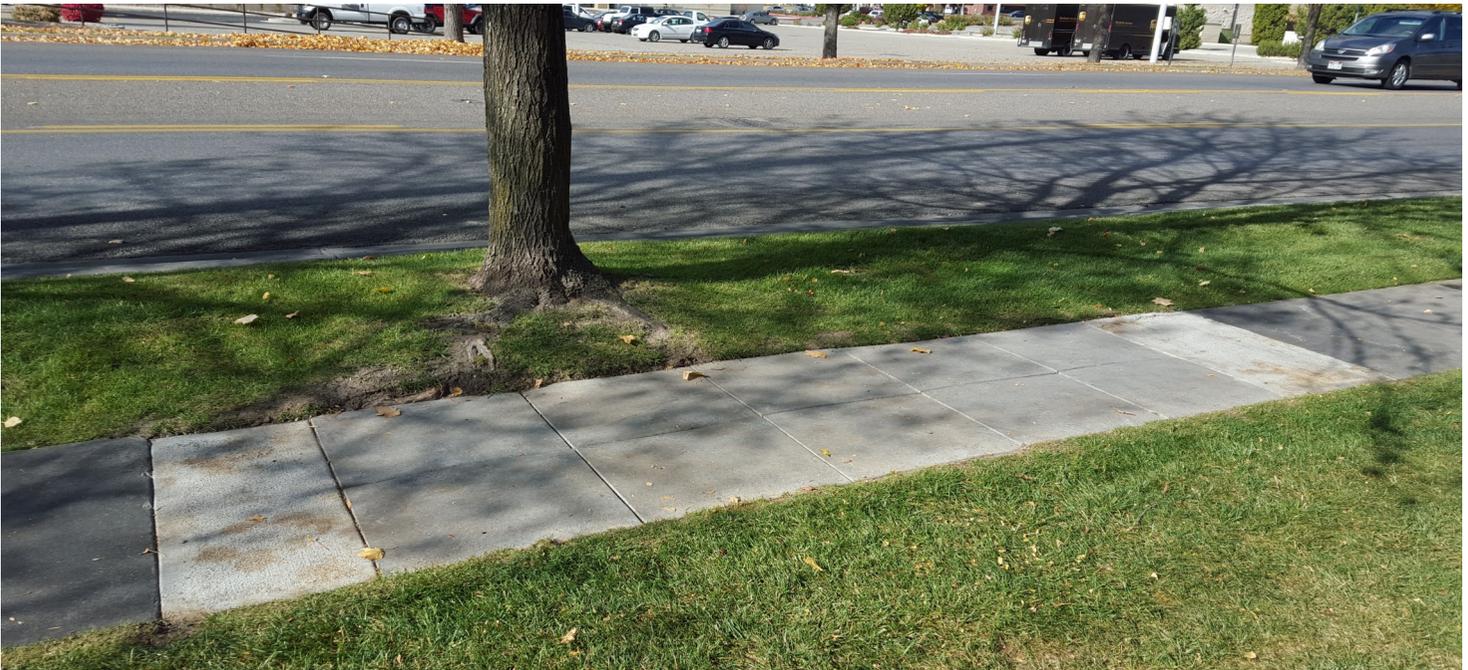
Another sidewalk installation site in Logan located at 1300 North 200 East. The close proximity of the Cache Valley Mall and Logan Pointe Apartments made this sidewalk a high priority for Logan City officials after the adjacent tree had buckled the old sidewalk in multiple places.
